Most drastic impact of sand extraction when a high and continuous extraction coincides with a varying nature in local geological layers and sediment types

Study areas and extraction history

Sampling methodology

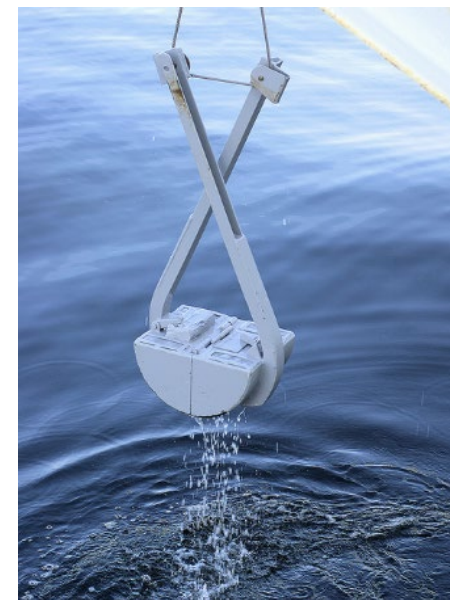
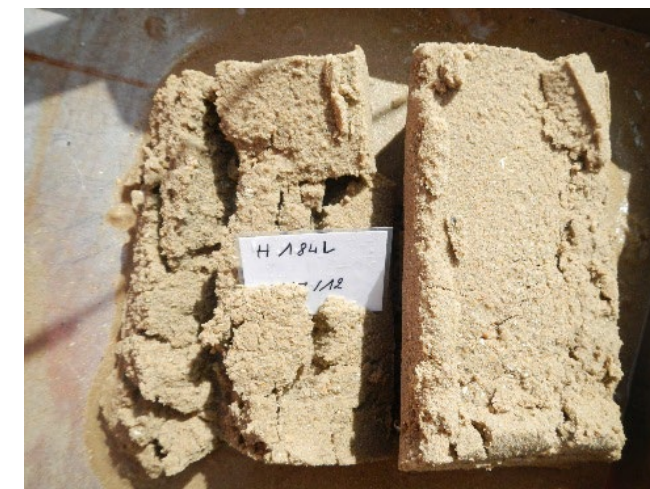
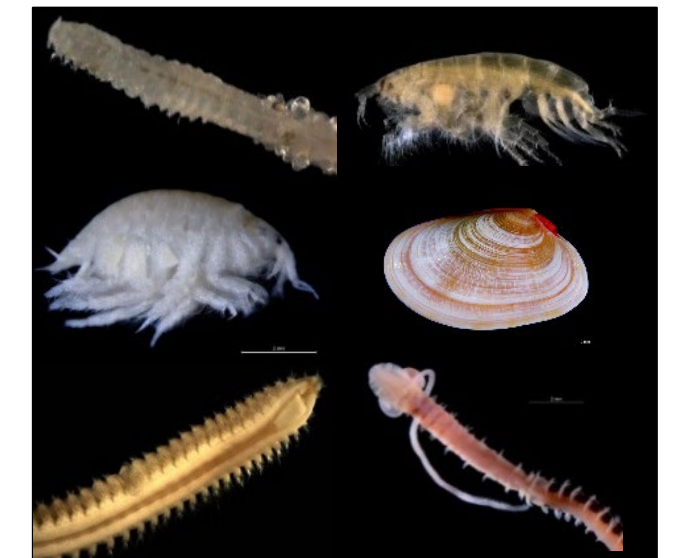
Grab sample derived sediment and macrobenthos

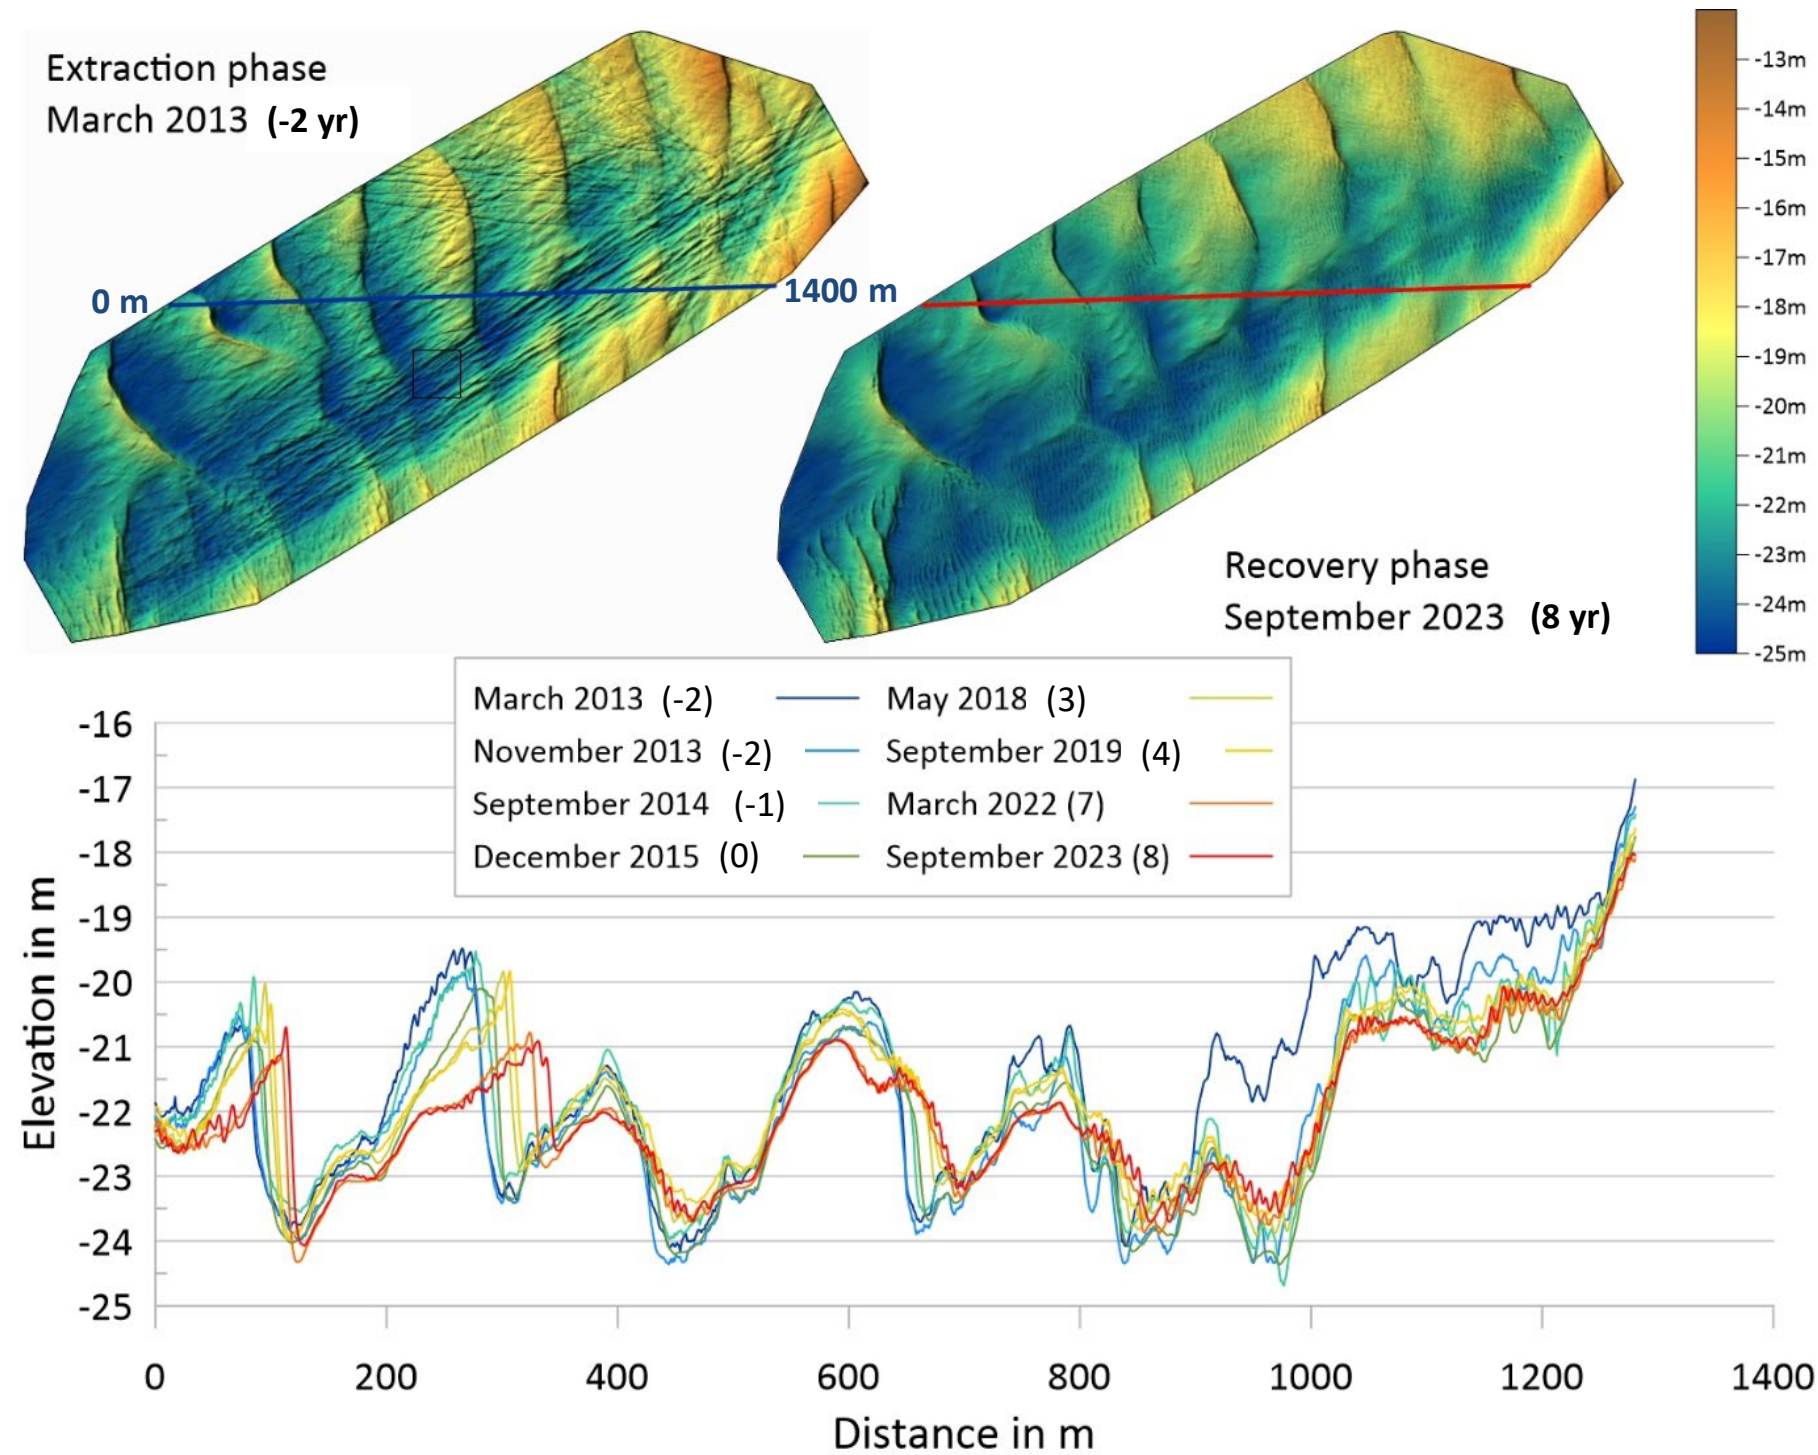
BR impact - Bathymetry & seabed morphology

- Bathymetry remains stable - no infill of depression created during dredging
- Dredge furrows gradually disappear
- Reappearance of small scale morphology – sand ripples after 3 years
- No recovery of larger scale morphology - sand waves.

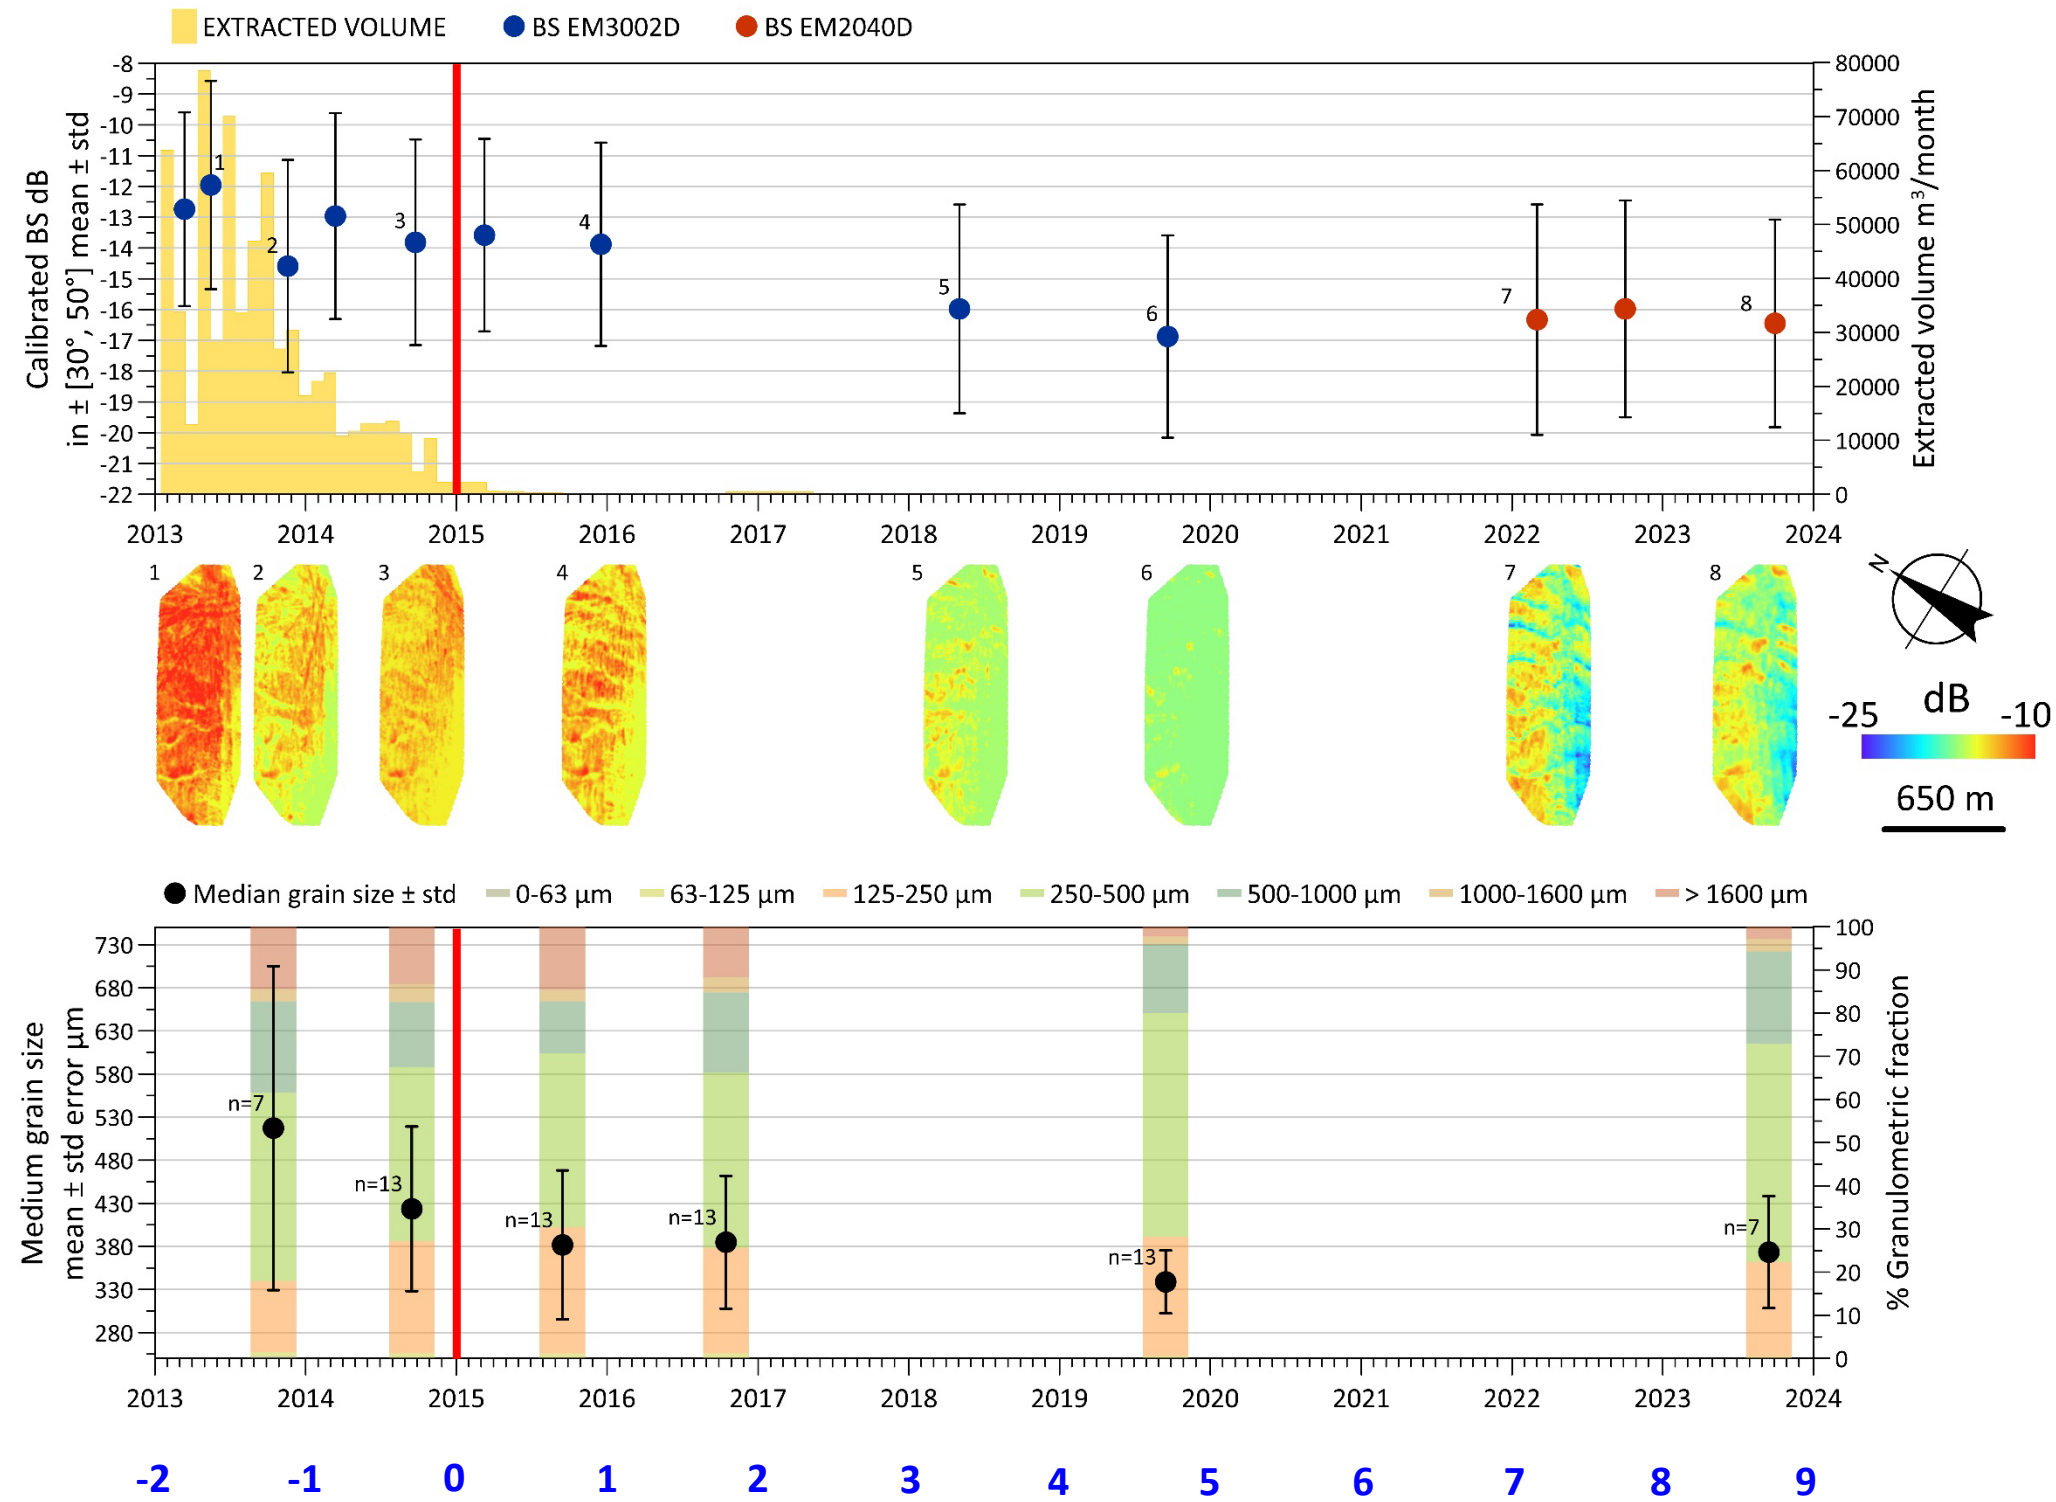
BR impact – Backscatter

- After cessation of extraction, BS levels decrease up to 2020, stabilizing afterwards ~sediment fining and decrease in rugosity
- The BS level is closely correlated with the % sediment $>160\mu m$.
- BS in years 7 and 8 reflects more natural small-scale morphology

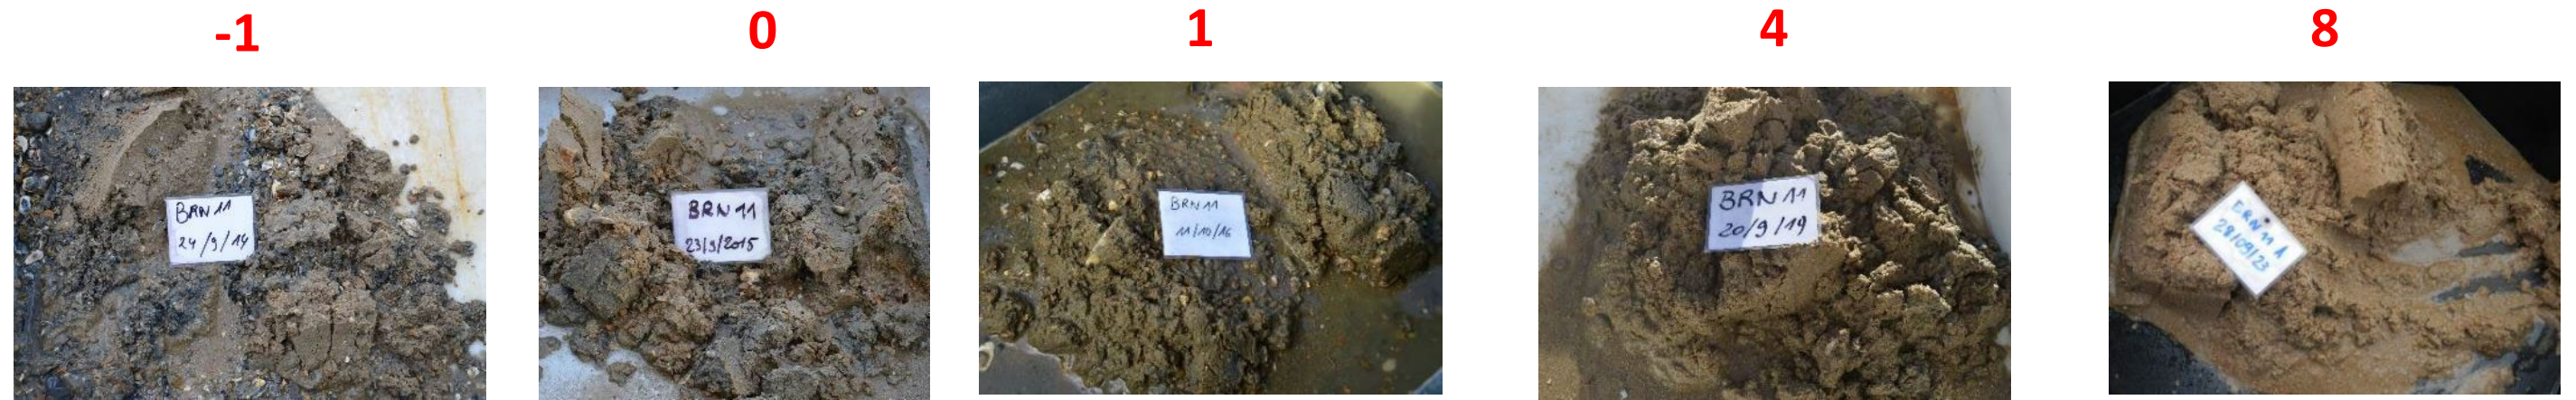
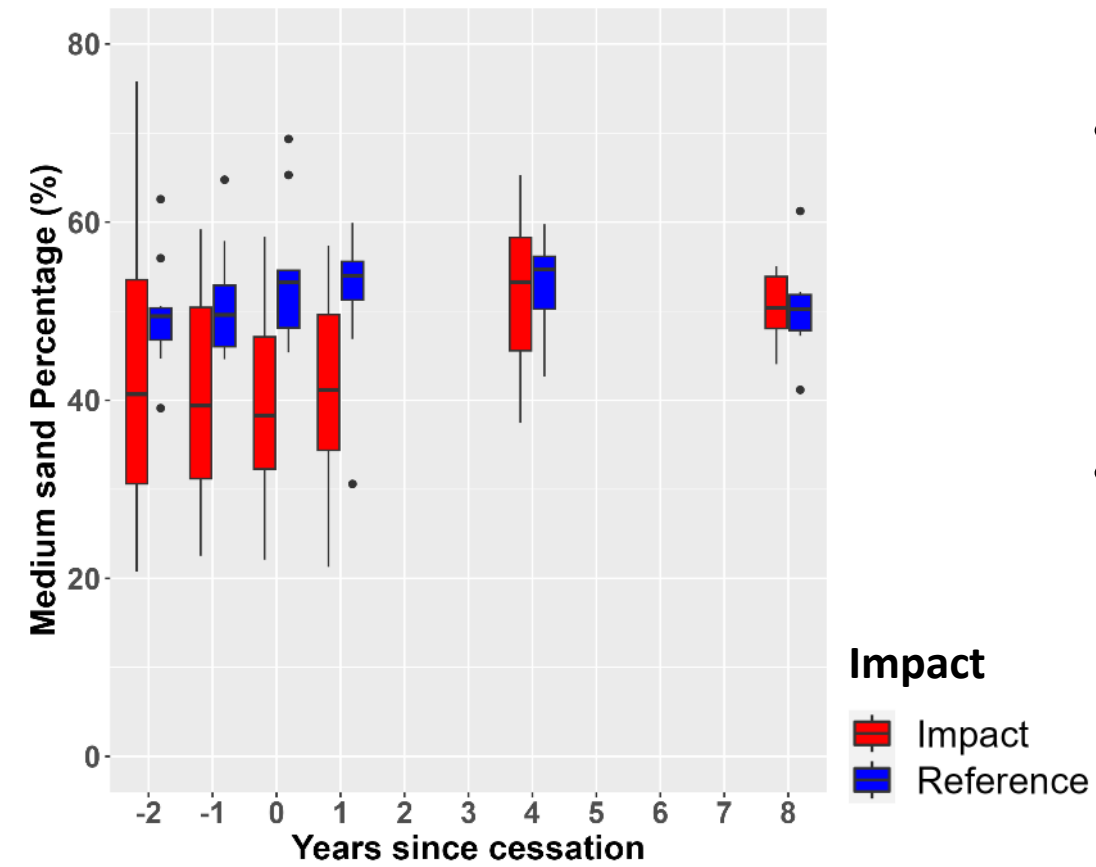
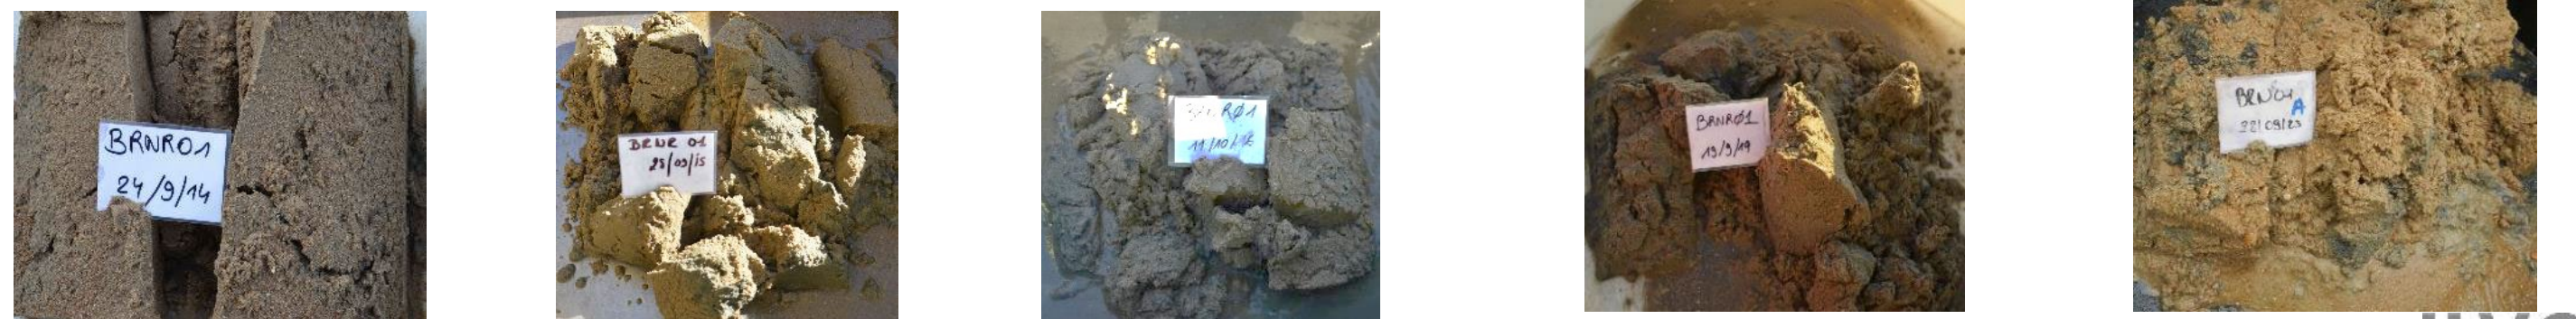
BR – Sediment evolution

- In impact area, relative decrease in >1600µm and increase in 250-500 µm fraction
- Sediment of reference locations stable over time

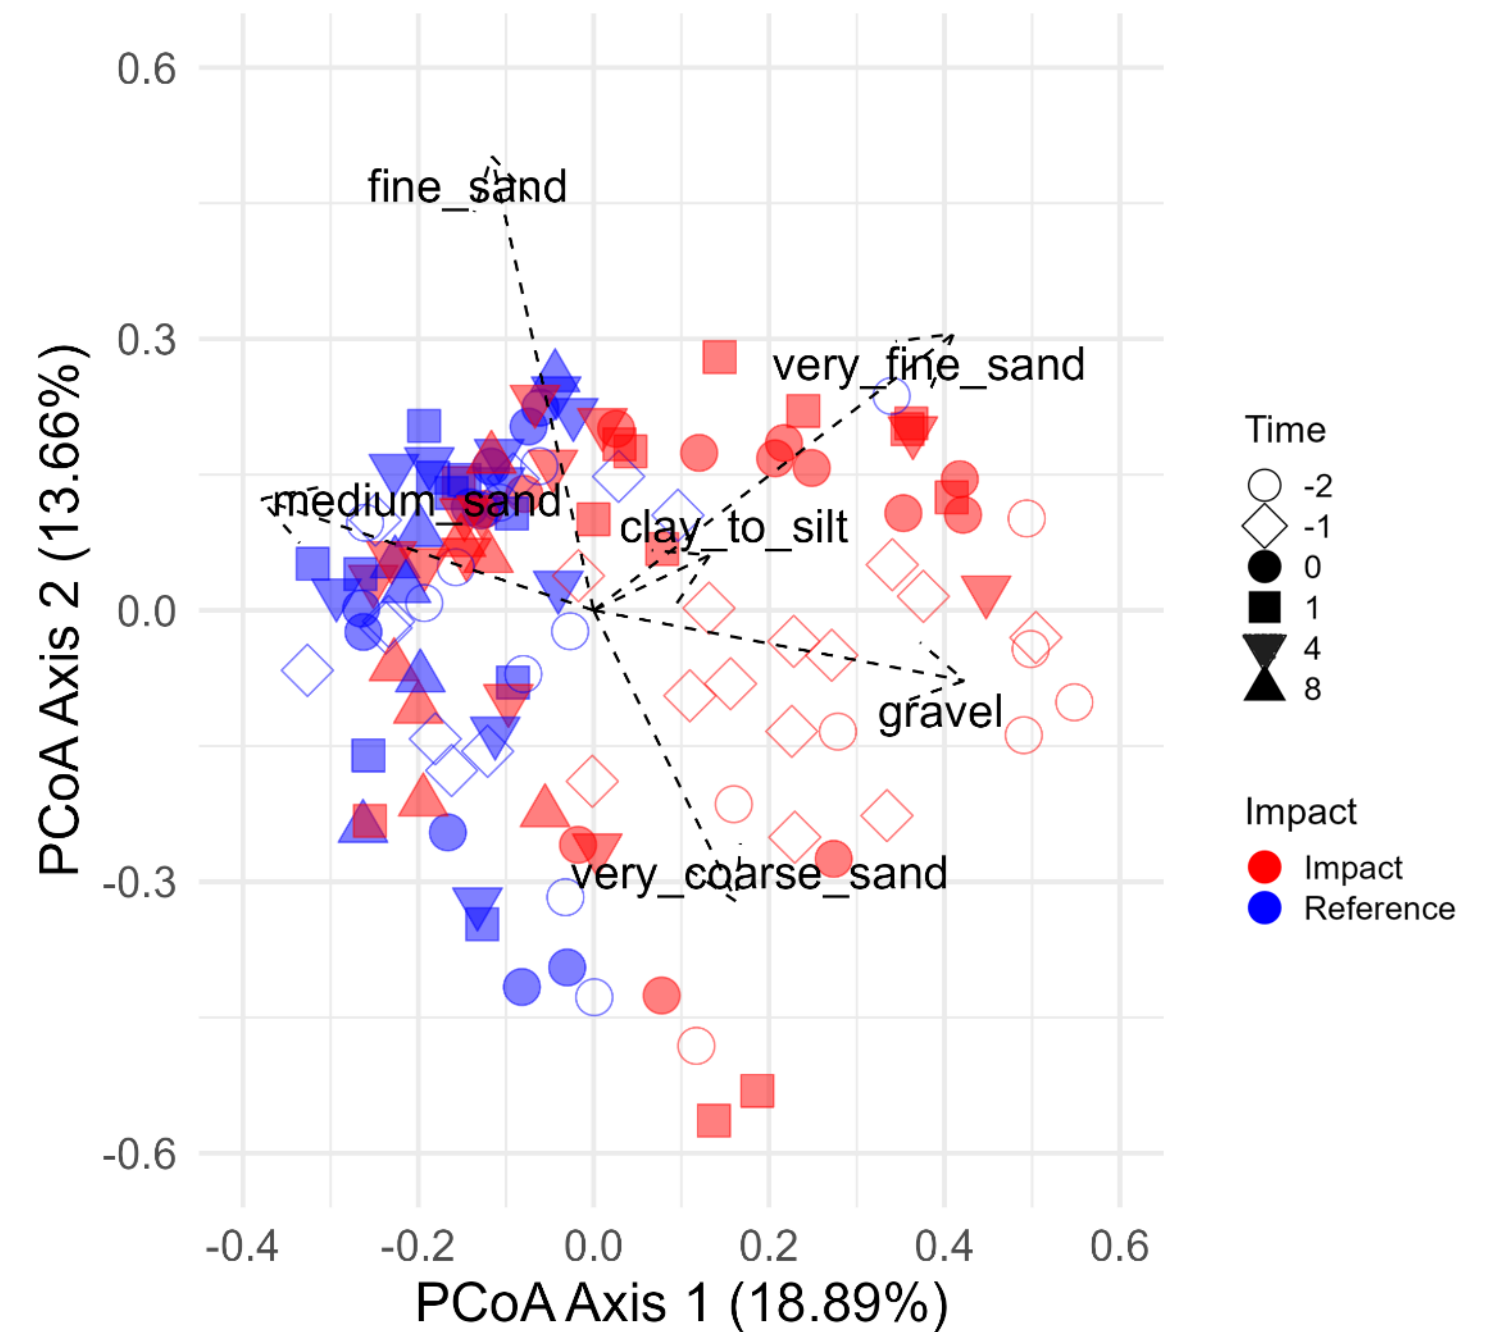
BR– Benthic community

- Colonisation of opportunistic species immediately after extraction
- Gradual recovery of benthic community to reference conditions after 4 to 8 years

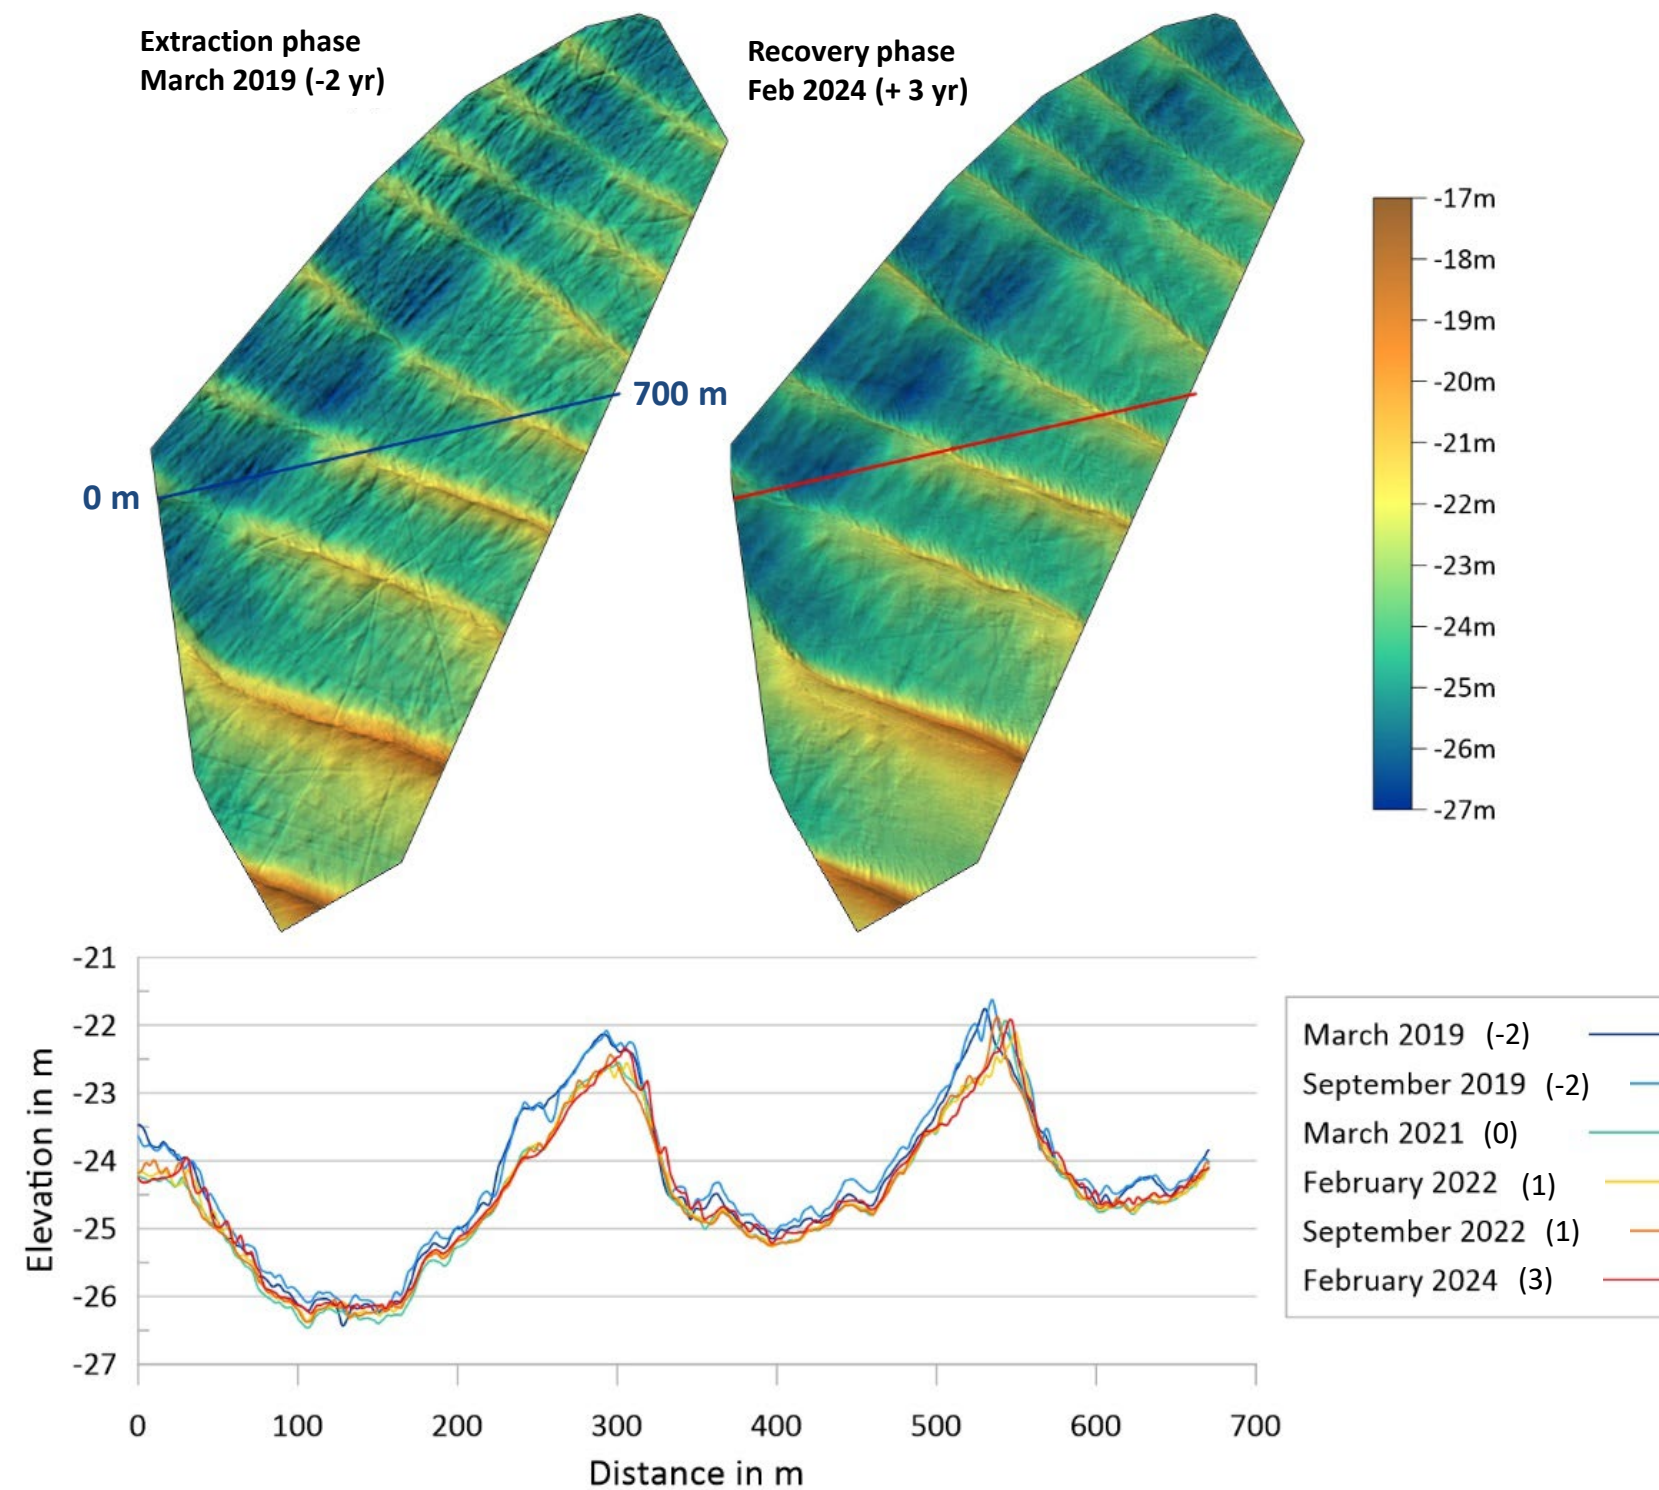
TB West – Bathymetry & seabed morphology

- Bathymetry stable after closure– no infilling of depression that was created during extraction
- Deep dredging furrows start to fill in immediately, and dredging marks are less apparent after 3 years
- No recovery yet of small and large scale morphology

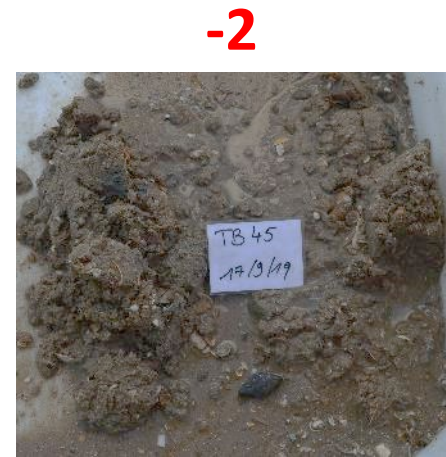
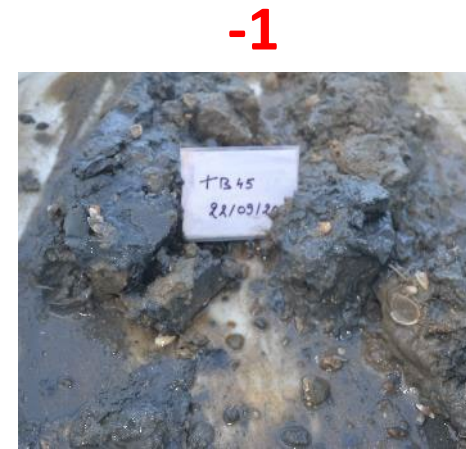
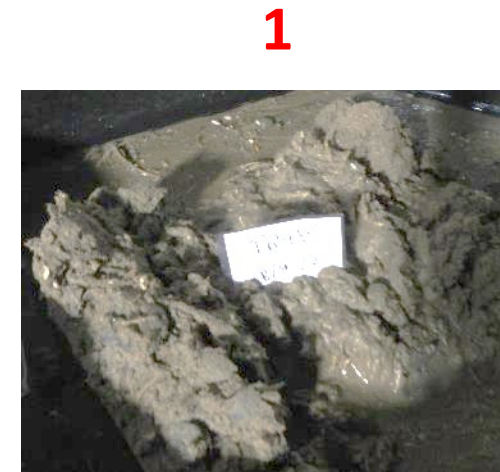
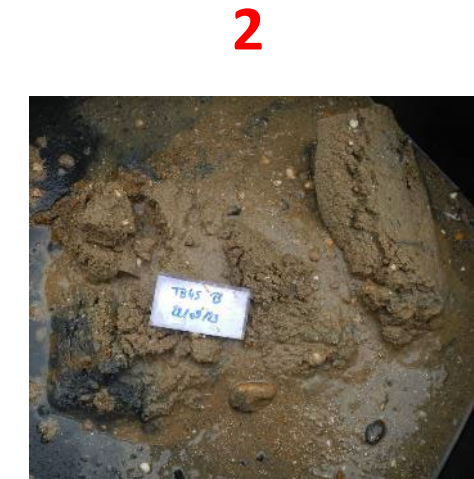
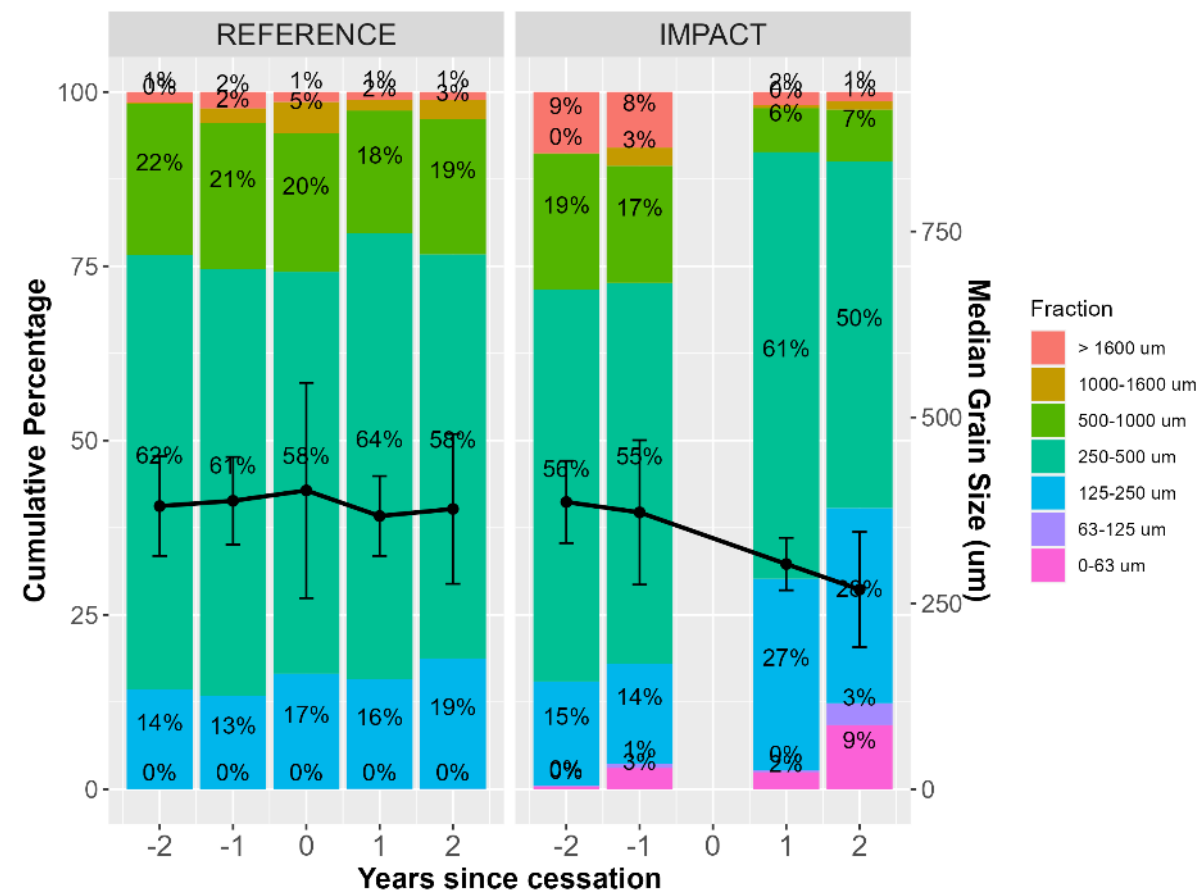
TB WEST - sediment

- In impact area, relative decrease in >1600 μm and 500-1000 μm and increase in fine fractions (0-125 μm)
- Sediment of reference locations stable over time

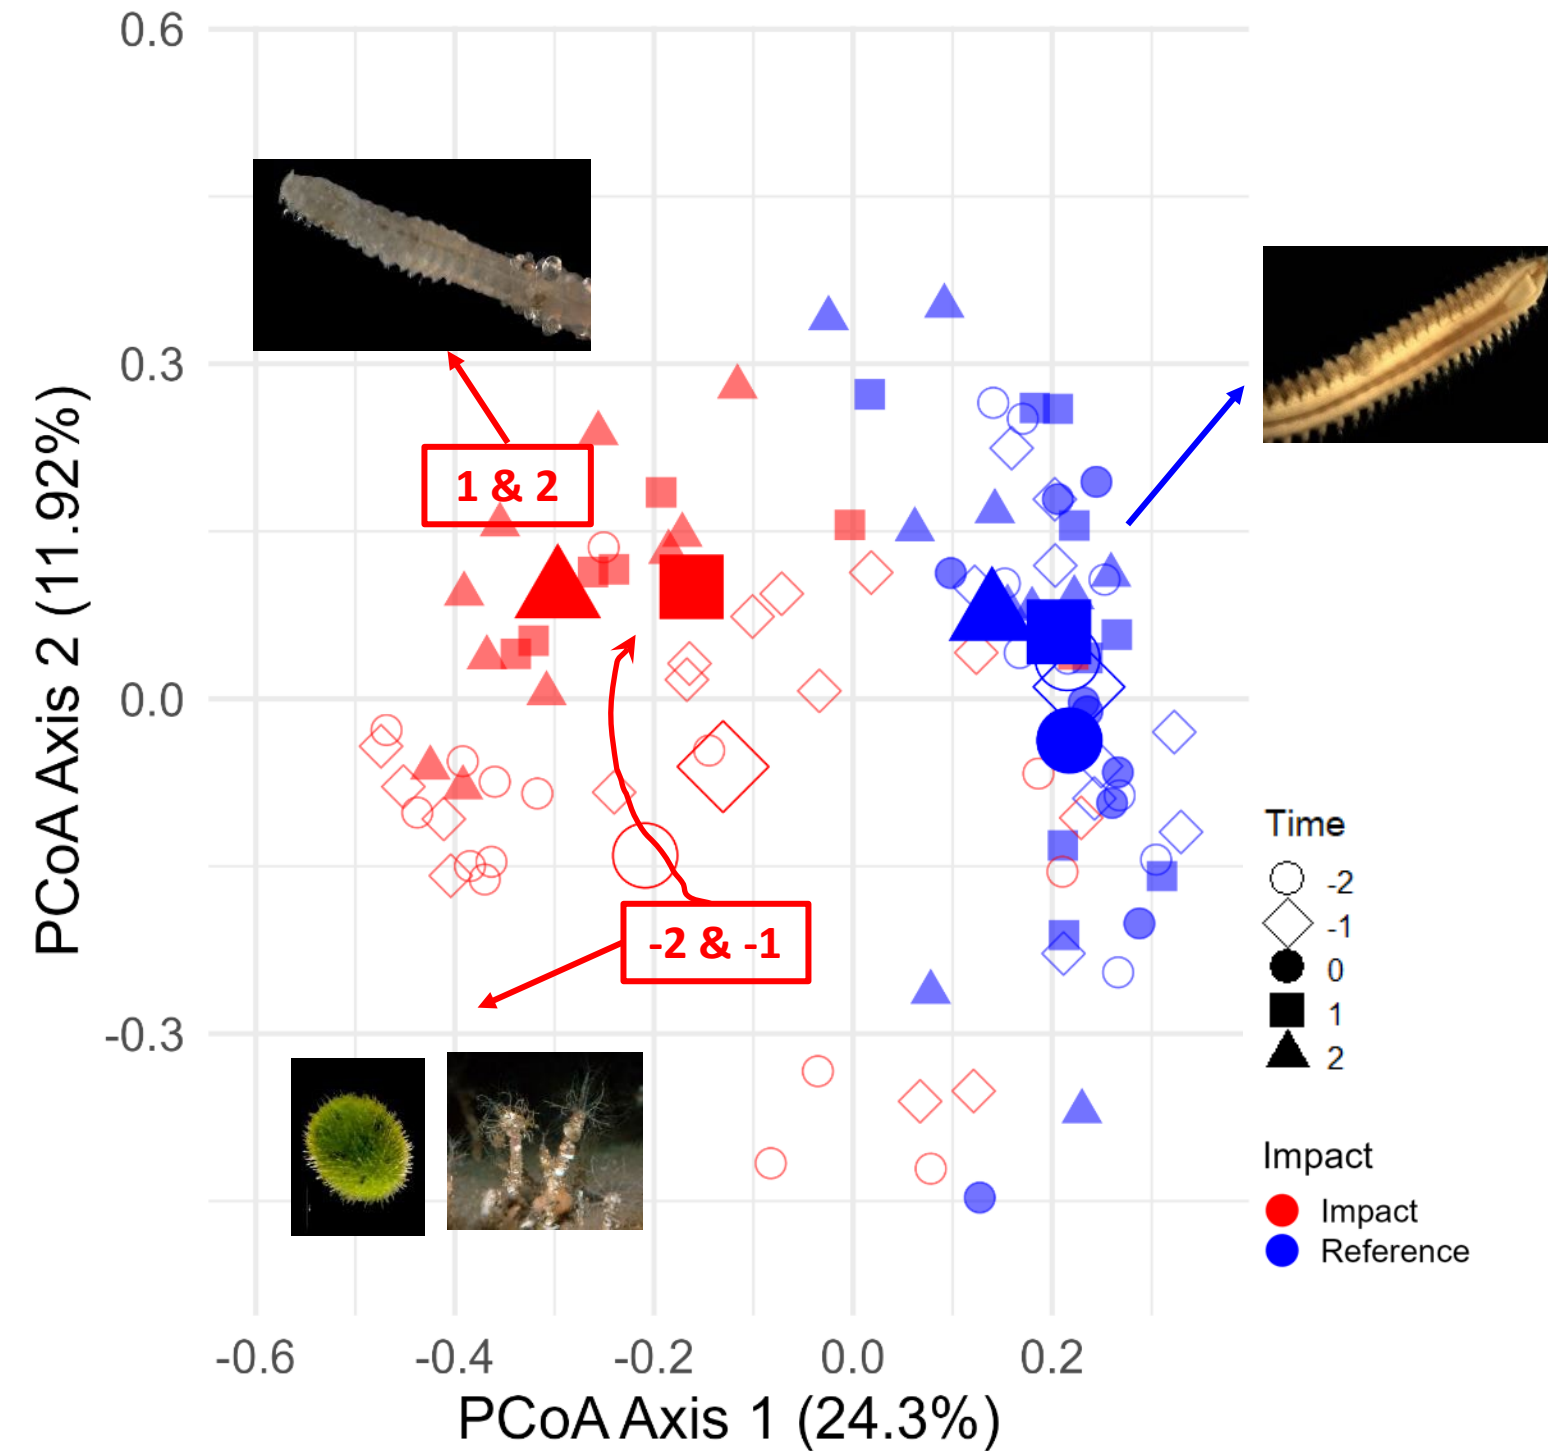
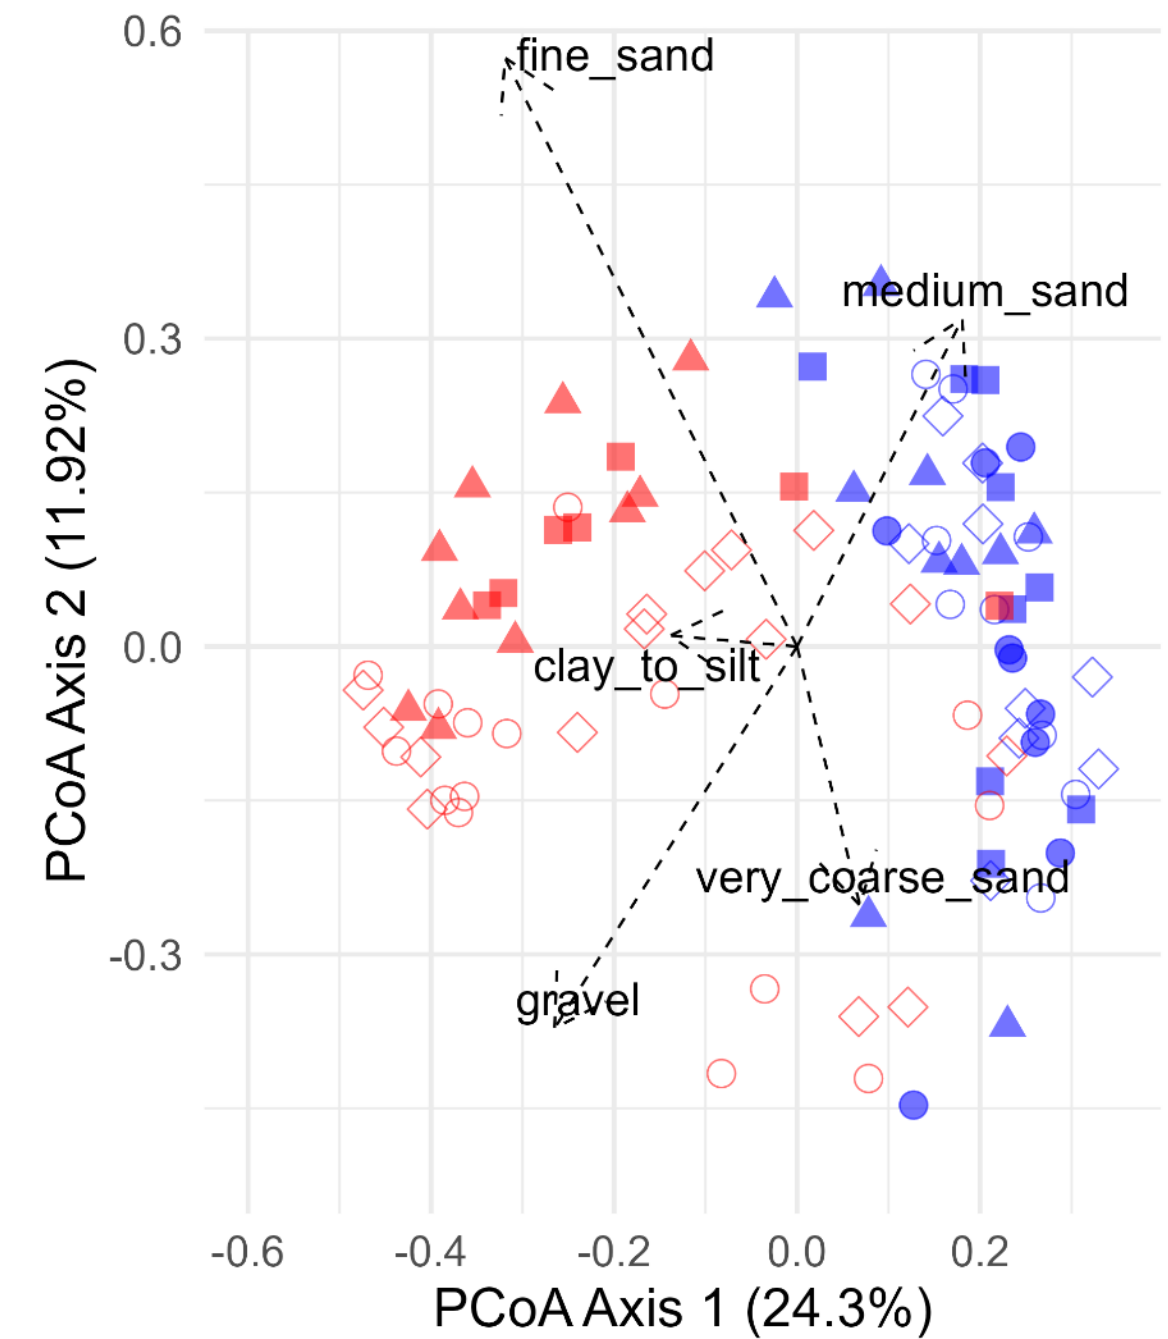
TB WEST

- Shift of community immediately after stop of extraction due to colonisation of opportunists
- No recovery of benthic community yet to reference conditions
